# TIP818

## Fault tolerant CAN Bus IP

### User Manual

## TIP818-10

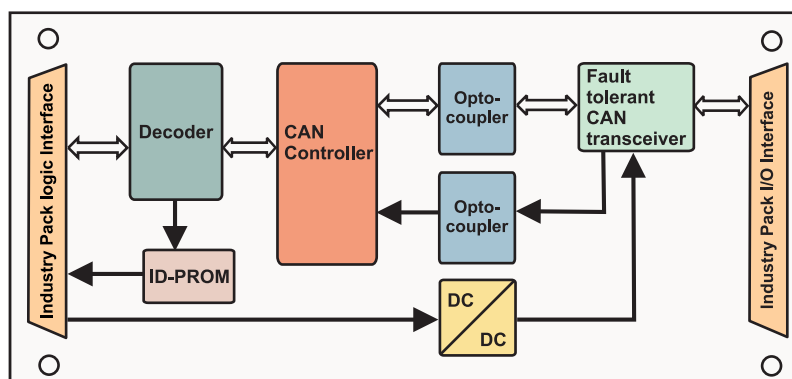
Figure 1-1 : Block Diagram

The TIP818 is an IndustryPack® compatible module and provides a complete CAN bus interface using the Intel 82527 CAN controller. The Intel 82527 CAN controller supports the standard data and remote frame as well as the extended data and remote frame according to CAN specification 2.0 part A and part B. It has the capability to transmit, receive and perform message filtering on extended and standard messages.

The physical interface is a fault tolerant CAN transceiver, which supports the communication between the CAN protocol controller and the physical bus. The interface is optically isolated from the CAN controller.

The fault tolerant CAN transceiver supports transmission capability on either bus wire, if one of the bus wires is corrupted. The failure detection logic automatically selects a suitable transmission mode.
